4.3 Topography

Figure 4.3-1: Local Site Topography
 Patterson Crossing Retail Center
 Town of Patterson and Town of Kent,
 Putnam County, New York
 Source: Insite Engineering, Surveying & Landscape Architecture, P.C
 Scale: 1 inch = 300 feet

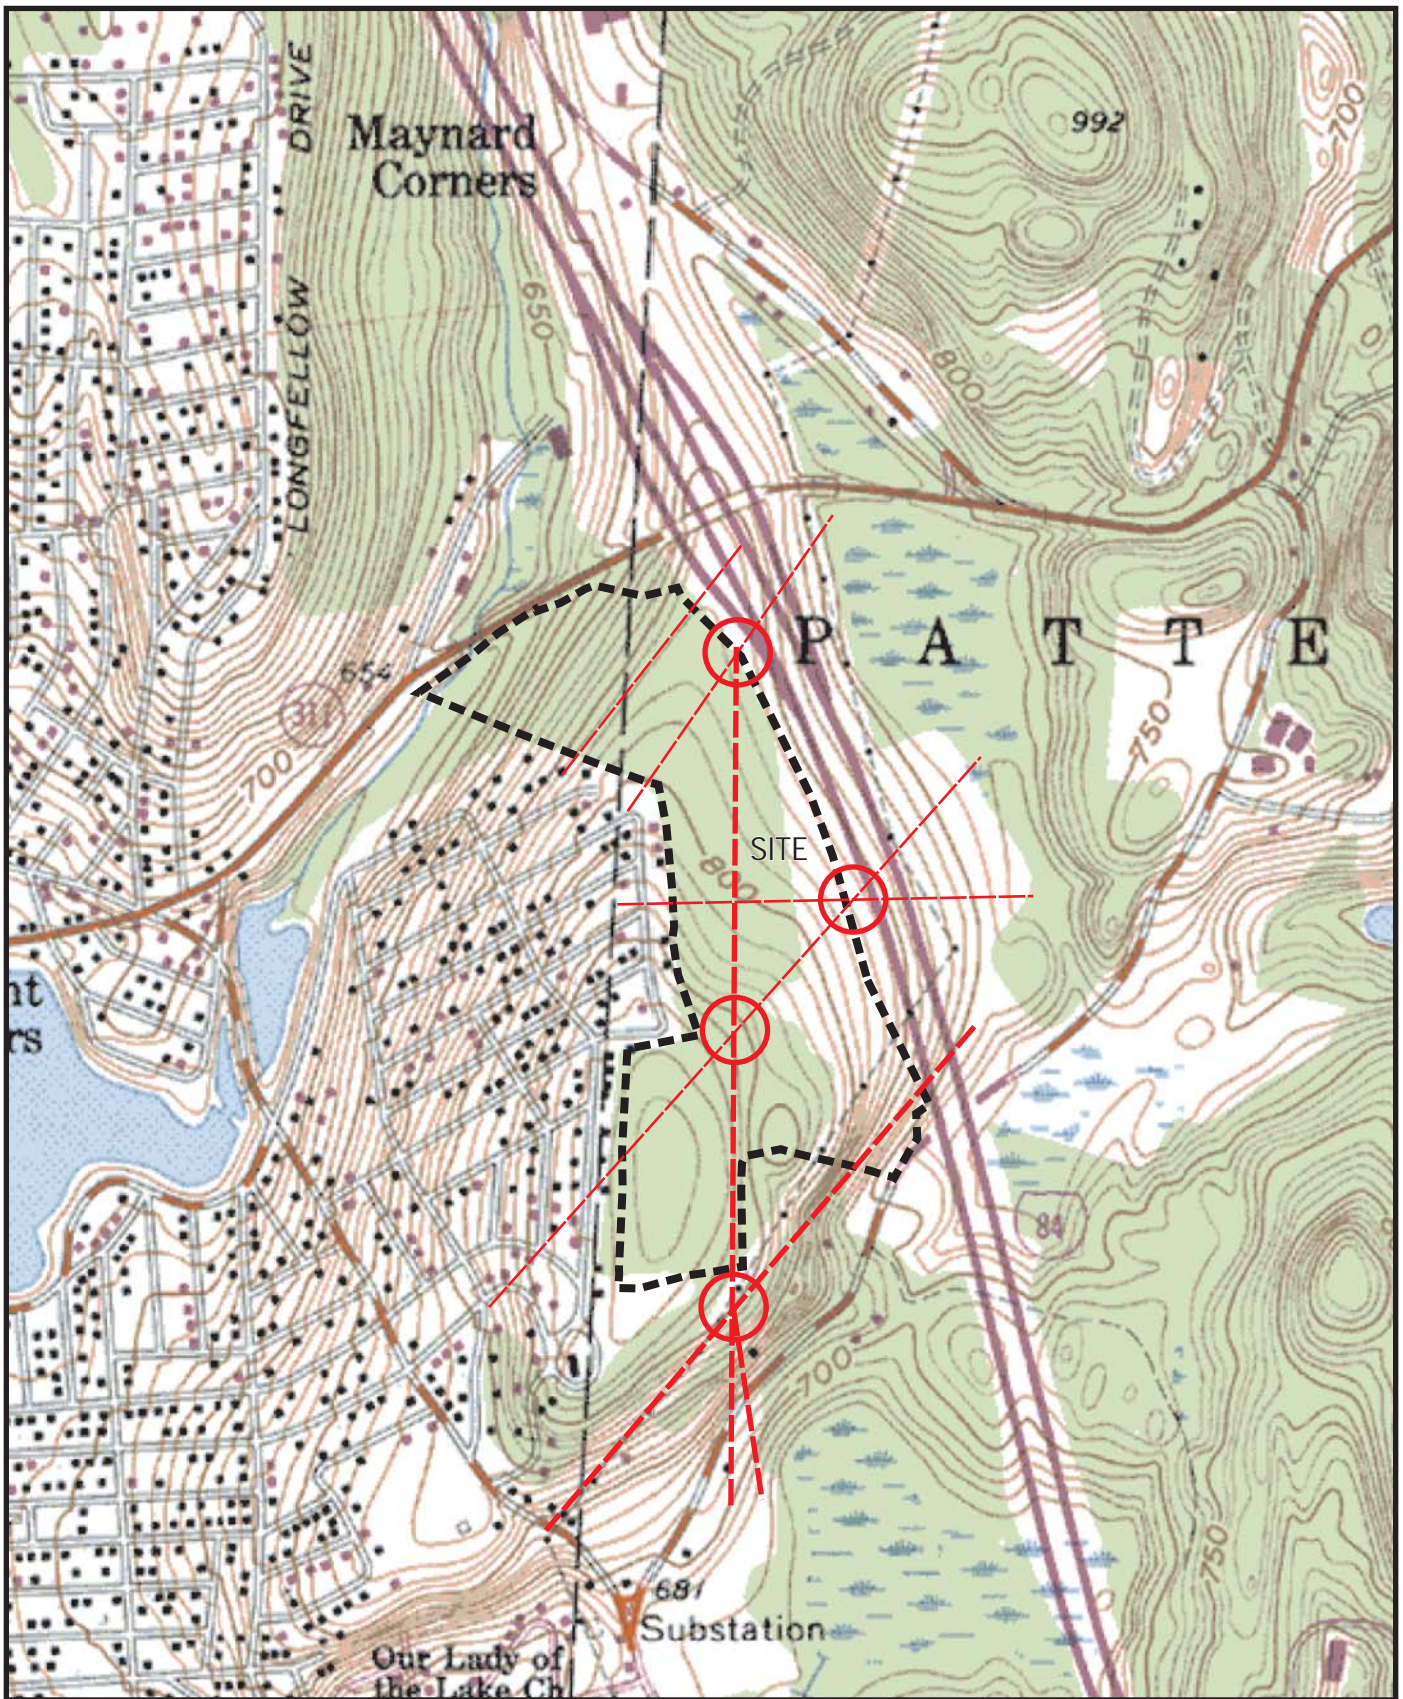
Major Fracture Trace
-

Minor Fracture trace
-

Figure 4.4-1: Fracture Trace Map
 Patterson Crossing Retail Center
 Town of Patterson and Town of Kent,
 Putnam County, New York

Review of the high altitude infrared photography shows that the project area has one major fracture trending from south to north through the approximate center of the site and a second major trace trending from southwest to northeast at the southern edge of the site. Fracture traces are shown in Figure 4.4-1, Fracture Trace Map. Several smaller traces were observed on the site, most trending southwest to northeast. The intersection of the major fracture traces occurs slightly south of the property boundary. Three locations appeared suitable for ground water development at the edges or within the property limits. These locations are at the intersection of the fractures shown on the fracture trace map (Figure 4.4-1).

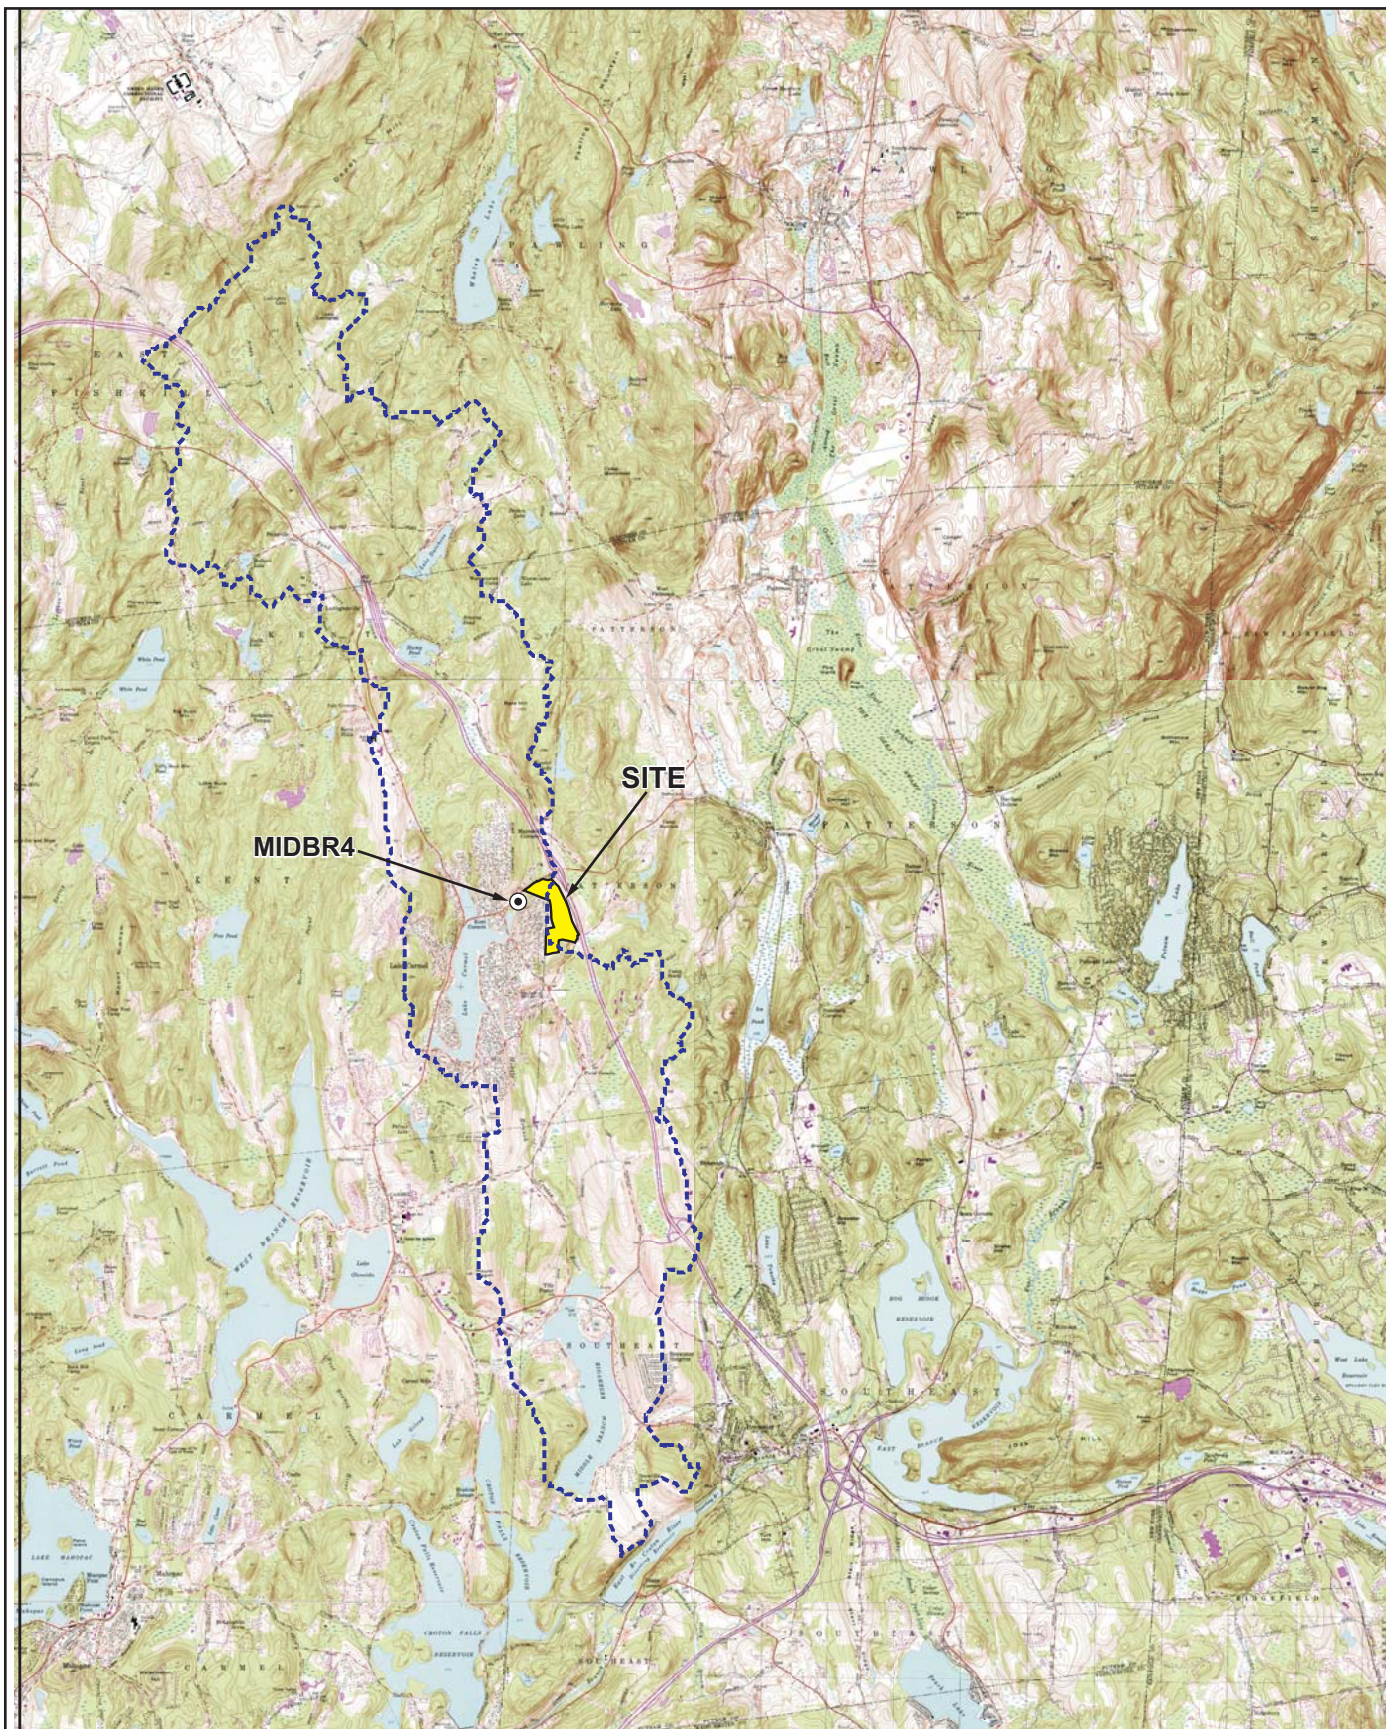
- - - - Middle Branch Watershed Boundary
- Site Property
- NYCDEP Water Quality Monitoring Site

**Figure 4.5-1: Middle Branch Watershed
Patterson Crossing Retail Center
Town of Patterson and Town of Kent,
Putnam County, New York**

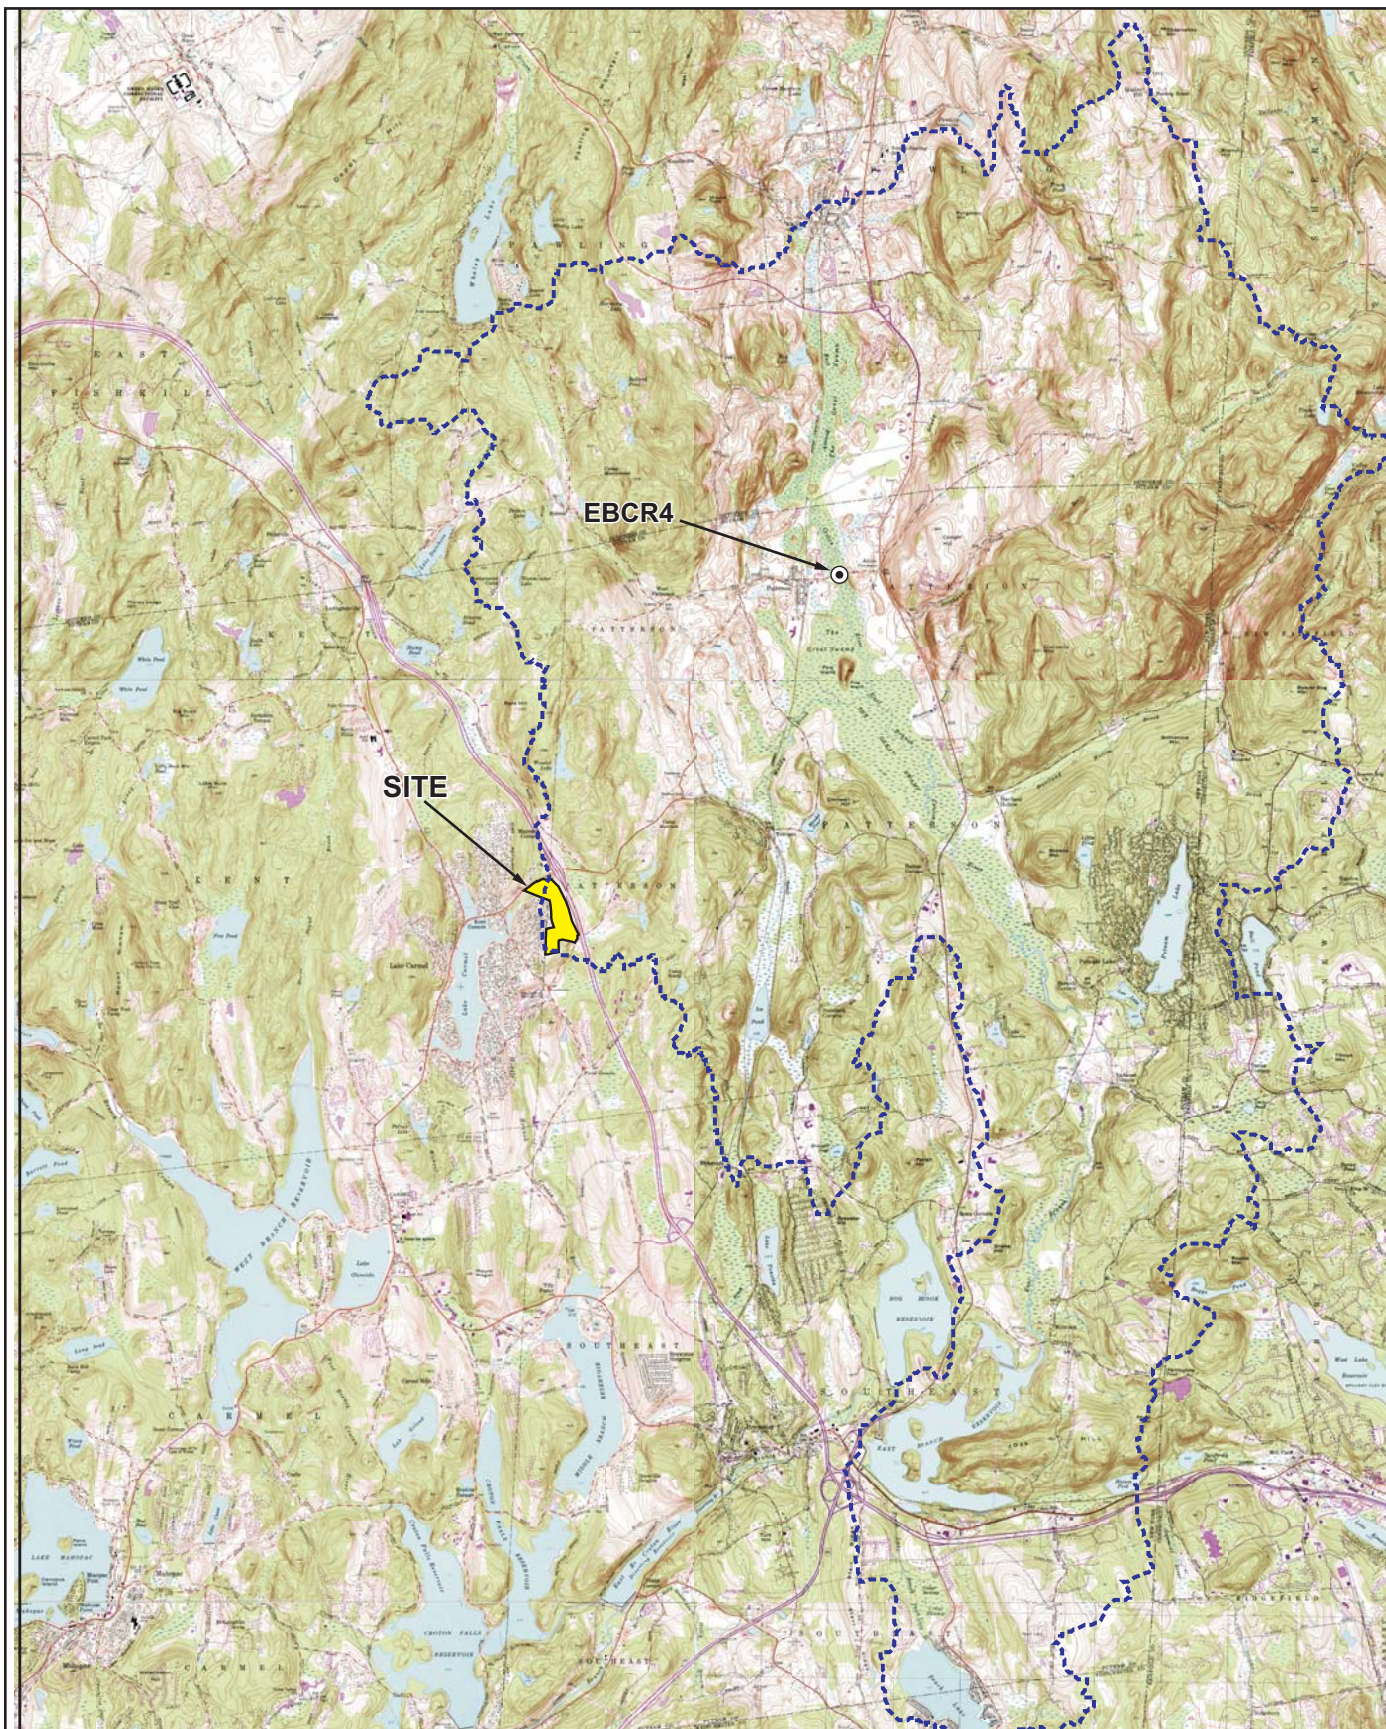
- - - - East Branch Watershed Boundary
- Site boundary
- NYCDEP Water Quality Monitoring Site

**Figure 4.5-2: East Branch Watershed
Patterson Crossing Retail Center
Town of Patterson and Town of Kent,
Putnam County, New York**

The monitoring site on the East Branch of the Croton River (EBCR4, shown on Figure 4.5-2) is located approximately one mile upstream from the discharge of Muddy Brook into the East Branch of the Croton River, thus representing conditions upstream of the project site. The monitoring site on the Middle Branch of the Croton River (MIDBR8, shown on Figure 4.5-1) is located approximately 2000 feet downstream from the northwest corner of the site, thus representing the pre-development condition. This sampling point includes runoff from the Lake Carmel community. Average values for the most recently reported sampling years (1998-2001) are shown in Table 4.5-4.

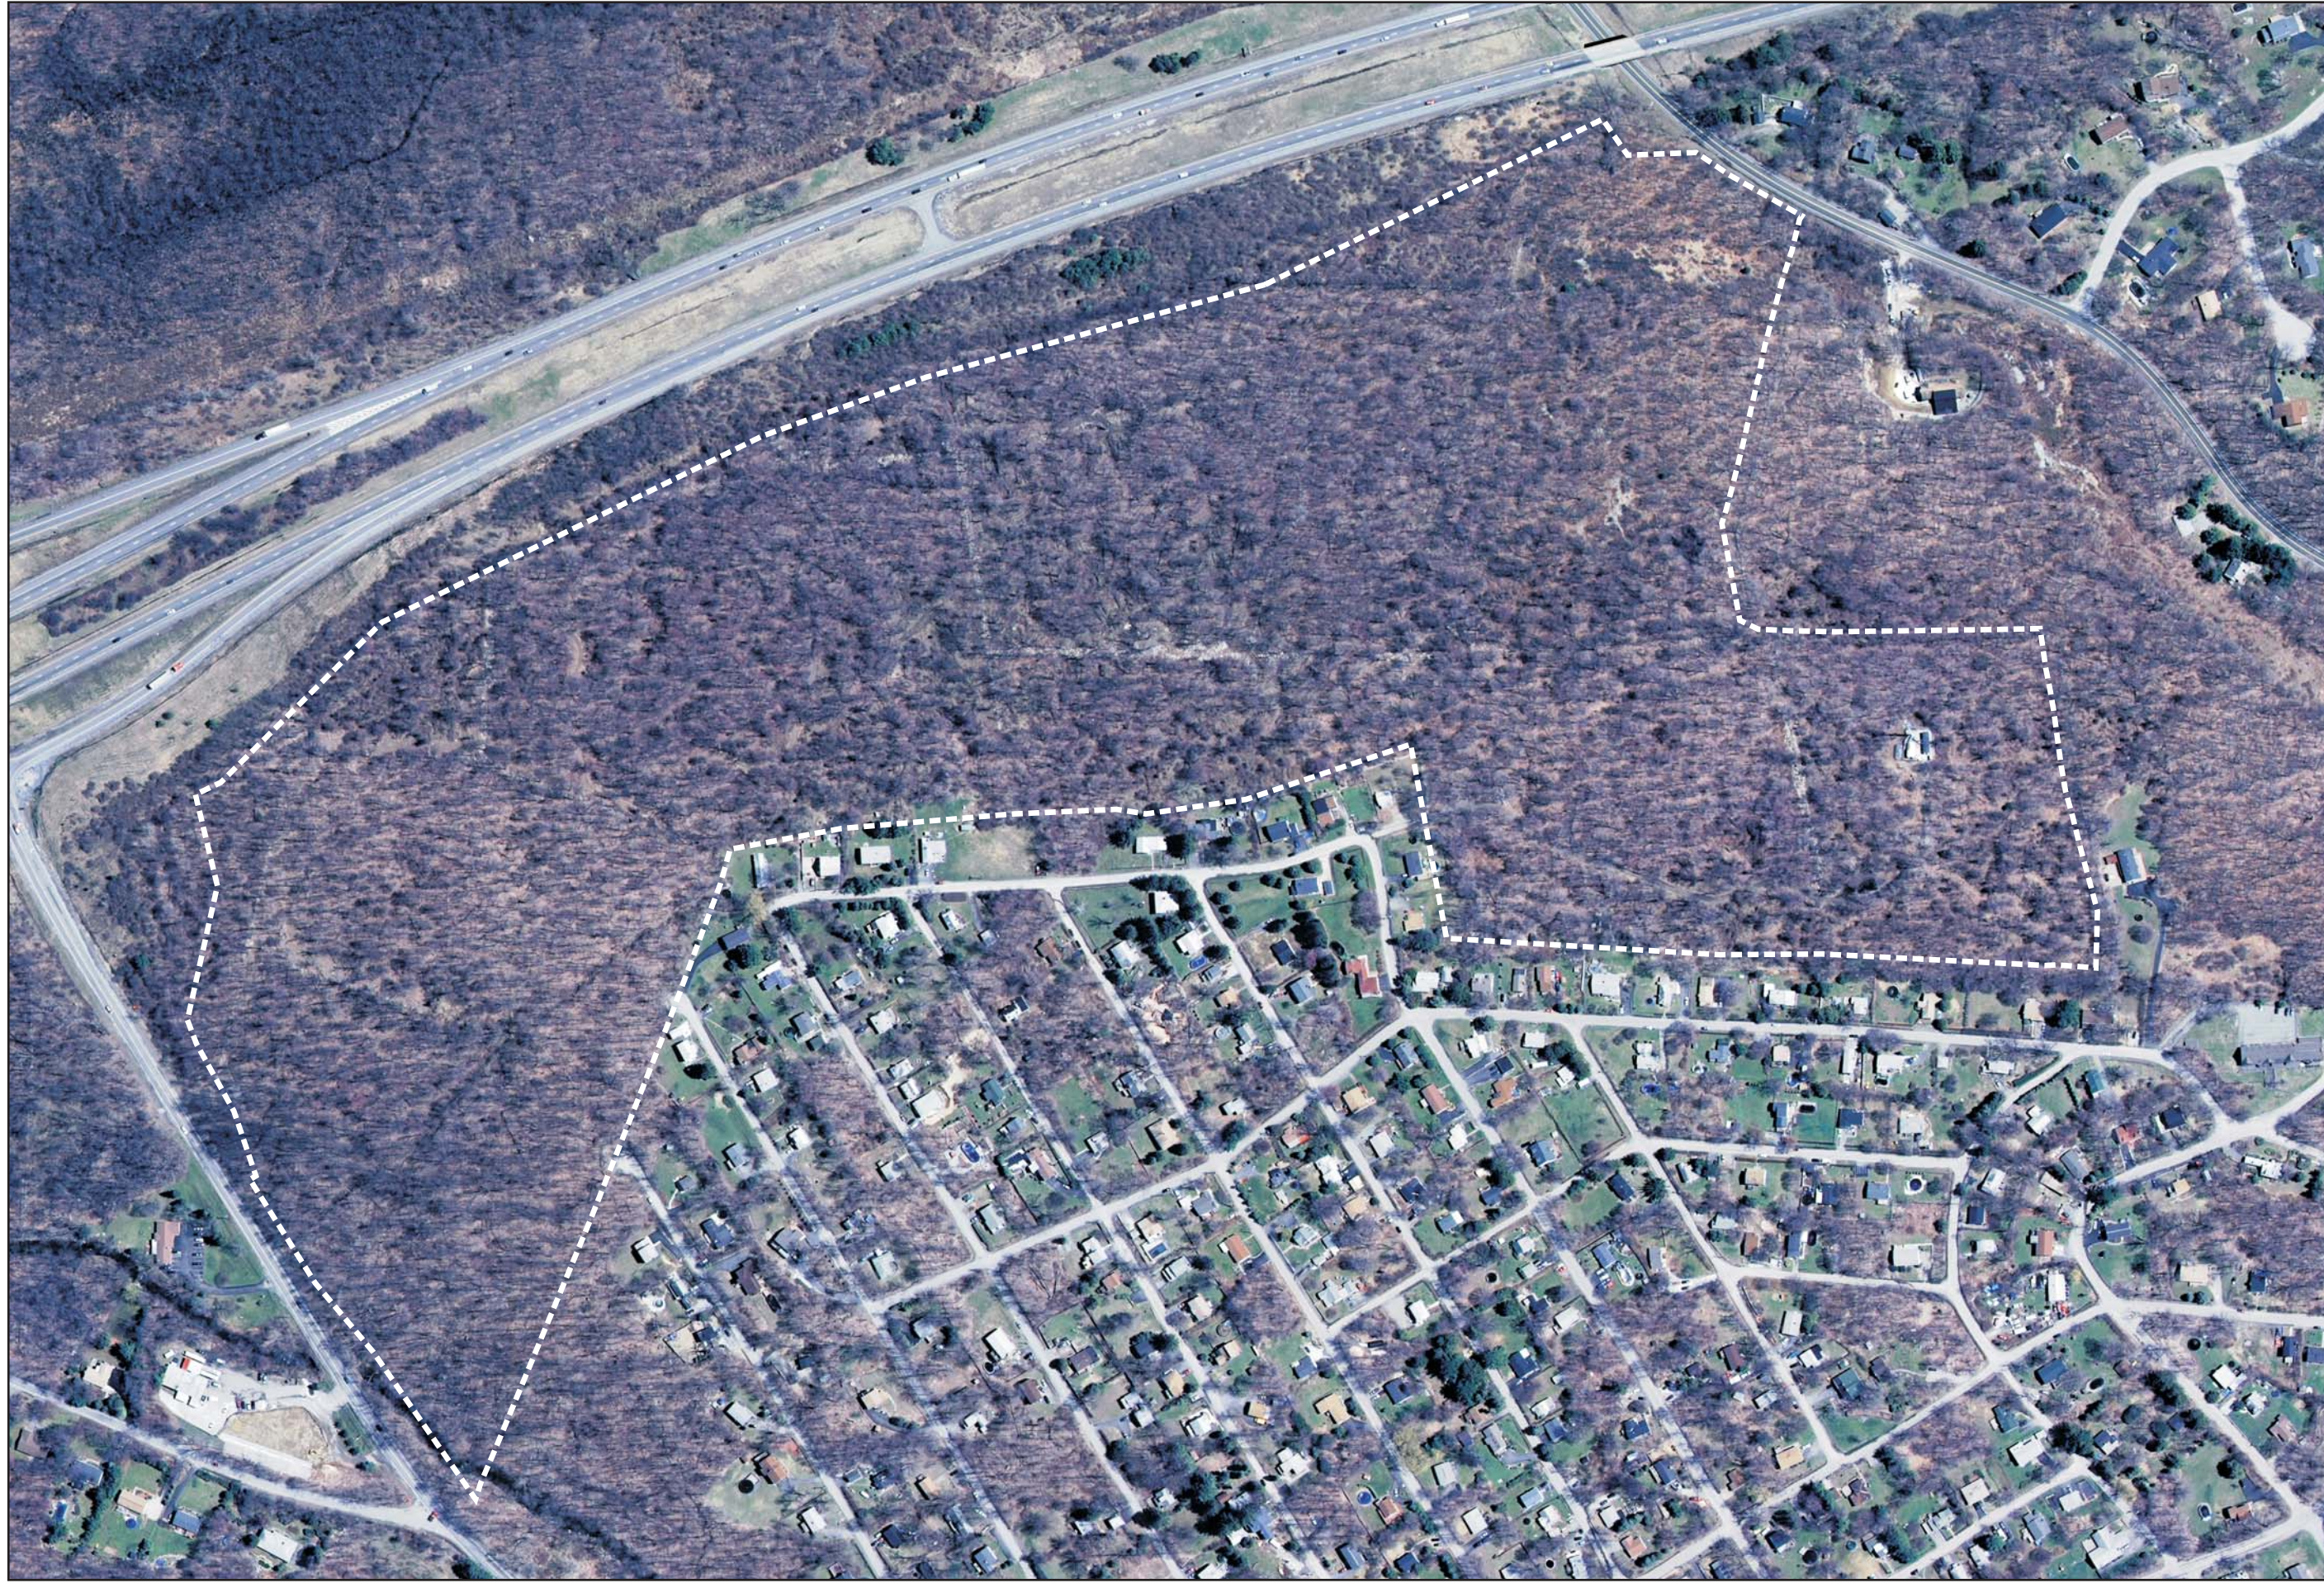
Figure 4.7-1: Aerial Photograph of Project Site
Patterson Crossing Retail Center
Town of Patterson and Town of Kent,
Putnam County, New York
Source: NYS GIS Clearinghouse, 2004 Aerial
Scale: 1 inch = 560 feet

The project site consists almost entirely of successional deciduous woodland with limited brushlands as shown on the aerial photograph provided in Figure 4.7-1, Aerial Photograph of Project Site. There is one small wetland regulated by the town of Kent that is located on the northern portion of the property near the site boundary with NYS Route 311.

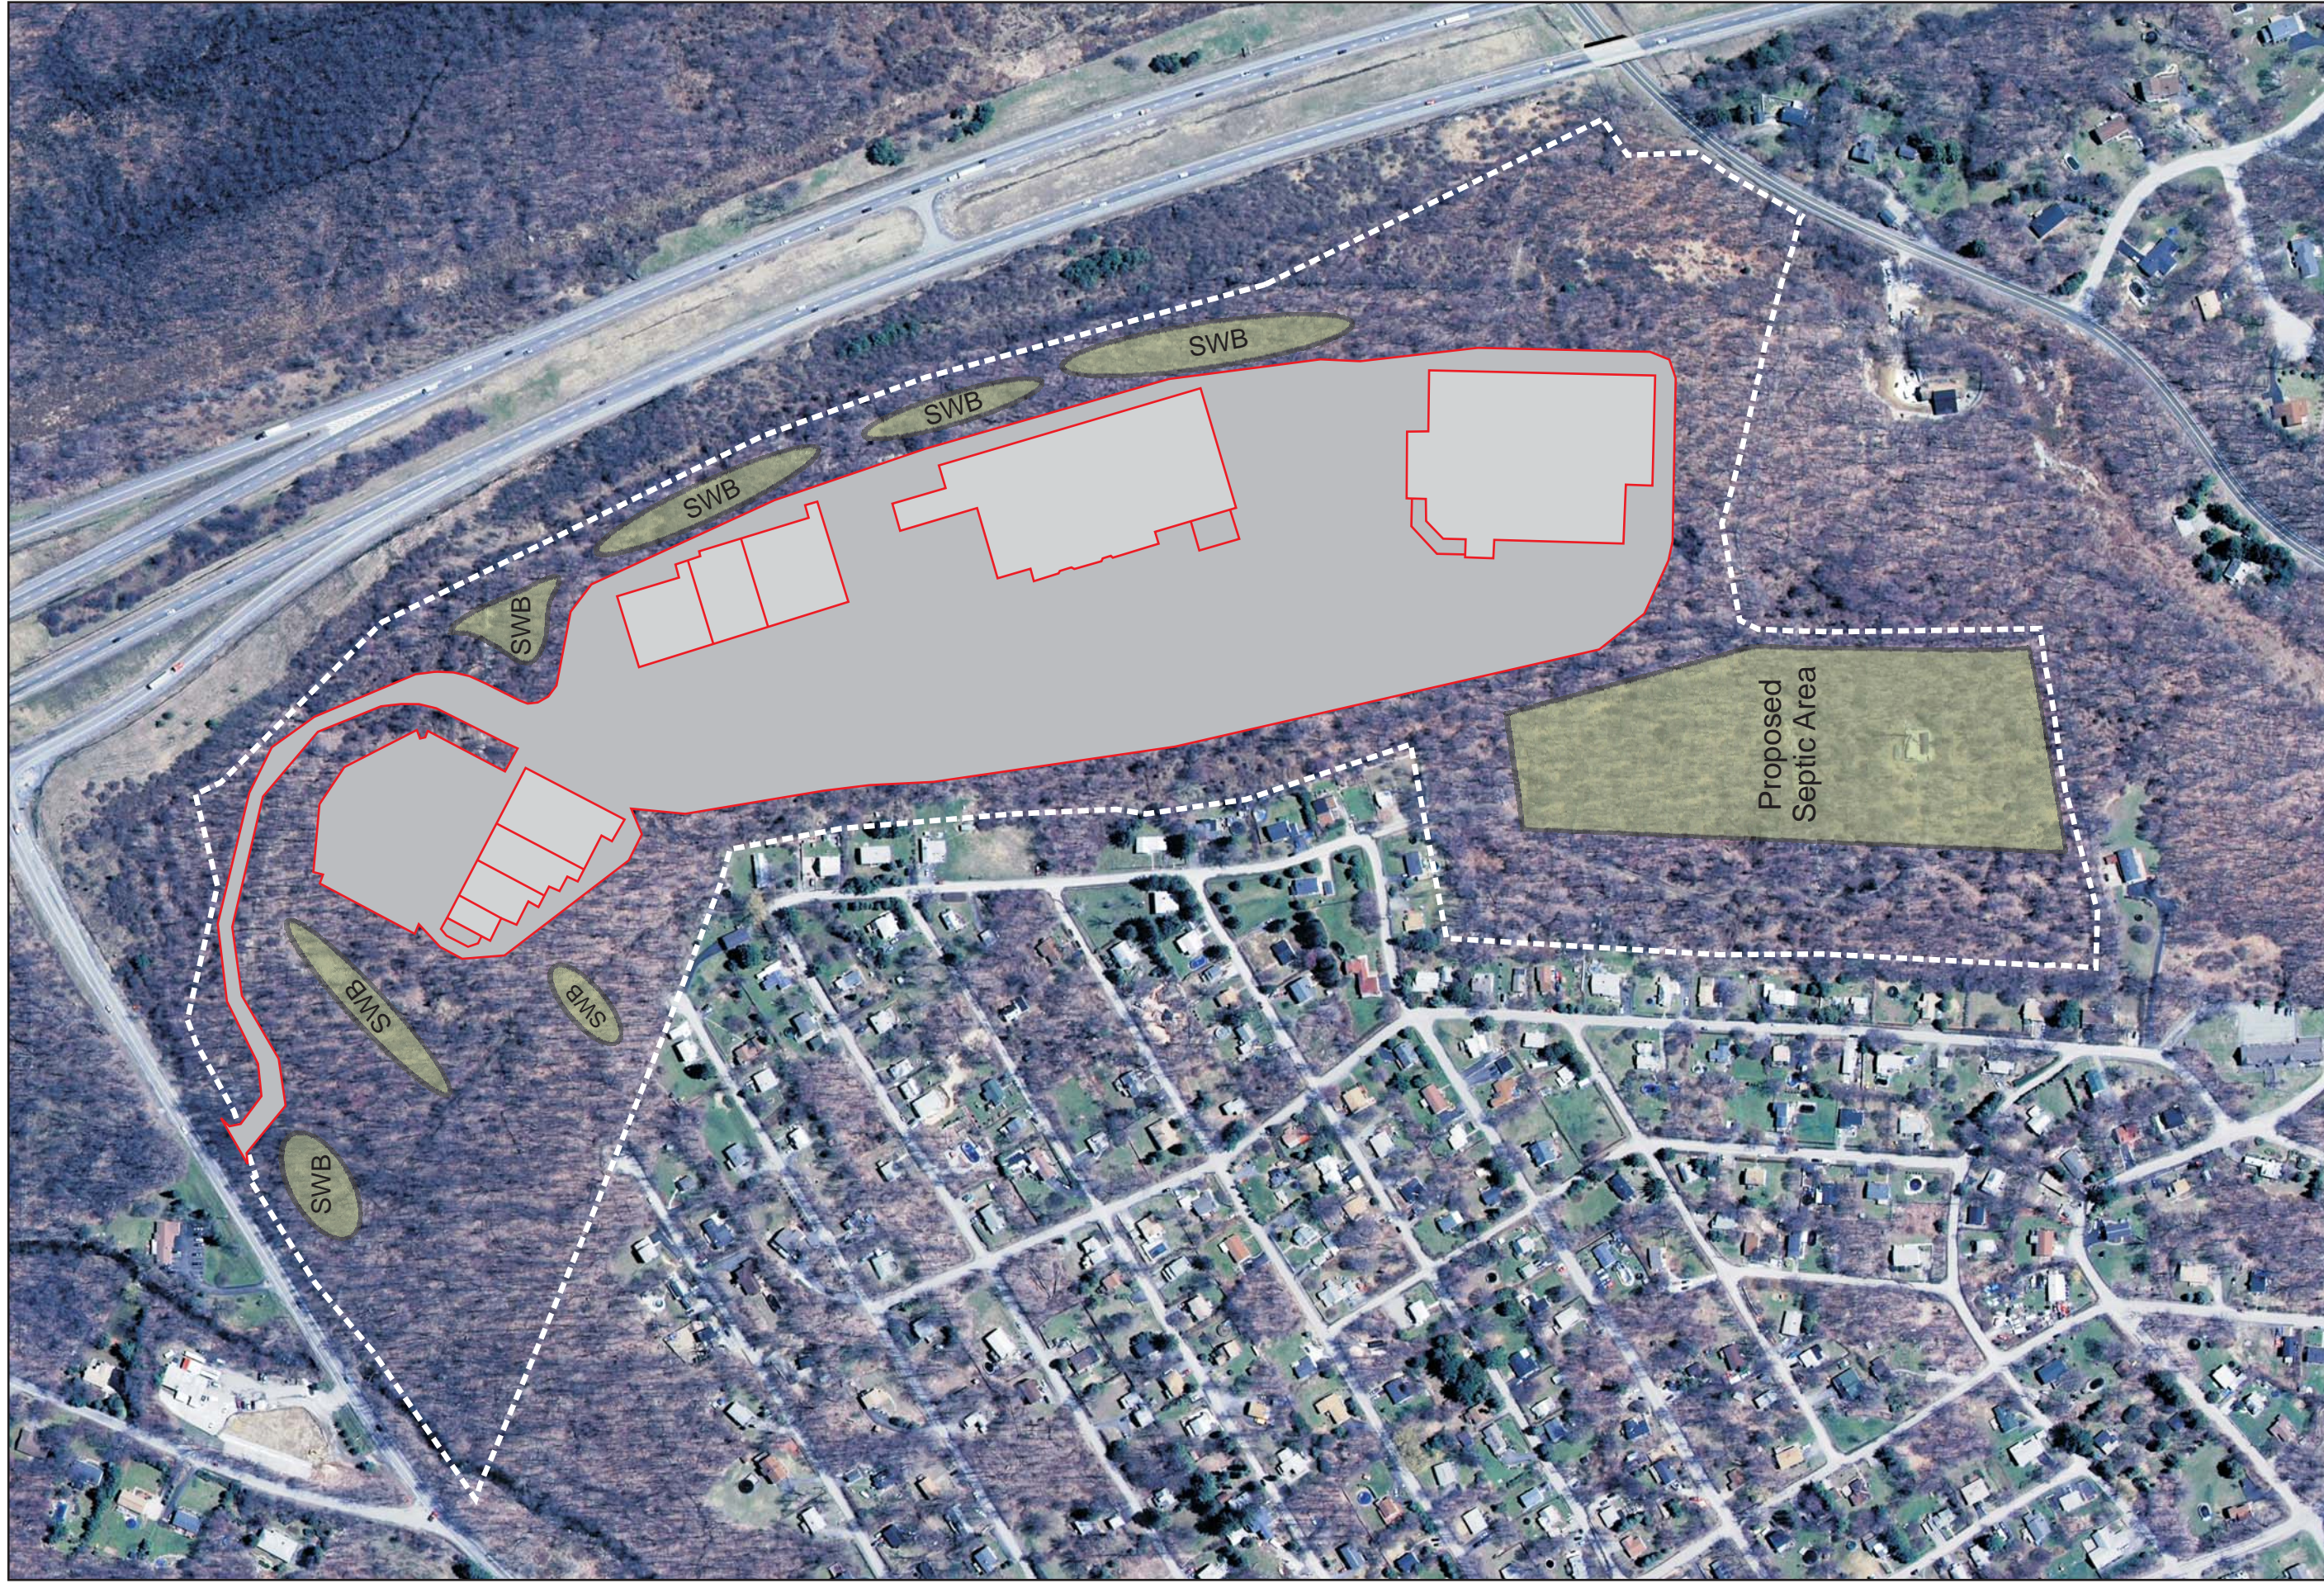
Figure 4.7-2: Post Development Vegetated Areas
 Patterson Crossing Retail Center
 Town of Patterson and Town of Kent,
 Putnam County, New York
 Source: NYS GIS Clearinghouse, 2004 Aerial
 Scale: 1 inch = 560 feet

As planned, the development would result in the clearing of vegetation from approximately 68.4 acres. Existing vegetation would be retained on the remaining 22.1 acres. All areas that are not proposed to be impervious surfaces will be re-vegetated, including the large area on the southern portion of the site that will serve as the septic area. Upon completion of the
